**PHASE I ENVIRONMENTAL SITE ASSESSMENT**

**NEW MUNICIPAL COURT SITE  
906 EAST ST. JOHNS STREET  
AUSTIN, TRAVIS COUNTY, TEXAS**

**Project No. 96077769  
Report Date: January 15, 2008**

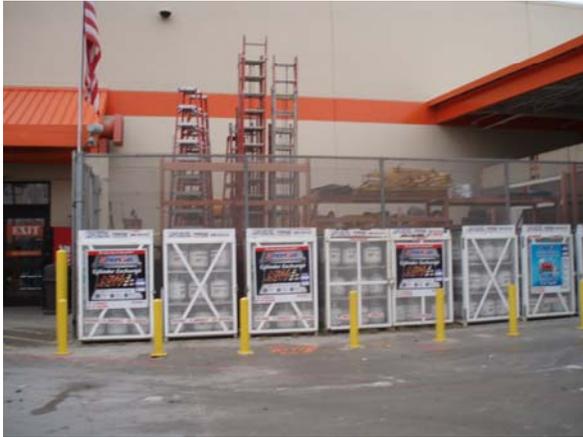
Photo 7 Propane exchange program

Several ASTs containing propane were observed on the site during the site reconnaissance. Home Depot offers a propane exchange program for 20 pound (typical gas grill) propane cylinders. Customers bring an empty cylinder and pay a fee to exchange it for a cylinder full of propane. Full cylinders are also available for purchase. The filling of cylinders is done off-site. Based on this information, the on-site propane exchange ASTs do not appear to constitute a REC in connection with the site at this time.

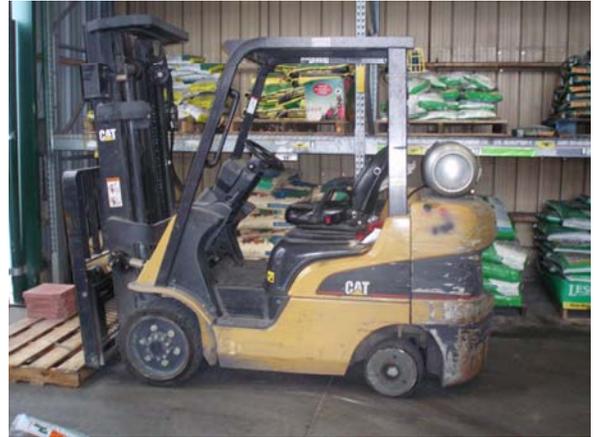
Photo 8 Typical forklift

Several forklifts were observed inside the Home Depot store. No staining was observed in the vicinity of the forklifts. The forklifts are battery operated and no staining was observed in the charging area. The forklifts are stored throughout the store and used to move merchandise in various departments.

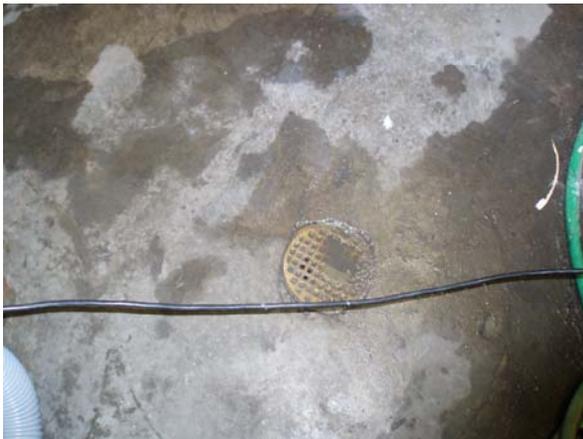
Photo 9 Floor drain inside janitorial closet

Interior floor drains were observed in the tool rental department, in the store restrooms and janitorial closet, and in the garden center. According to Mr. Taft, the floor drains in the tool department drain to the oil/water separator and the other floor drains are connected to the sanitary sewer. Evidence of staining or other releases to the floor drains was observed in the janitorial closet and the tool rental department during the site reconnaissance. Potentially hazardous materials did not appear to be stored in the vicinity of the janitorial closet floor drain. A janitorial sink was also observed in the janitorial closet. Evidence of staining was observed; however, no hazardous materials were observed in the vicinity of the janitorial sink. The tool department floor drains were stained with what appeared to be oil. Again, these drains lead to the on-site oil/water separator. This staining appeared to be a de minimus condition and does not appear to constitute a REC in connection with the site at this time.

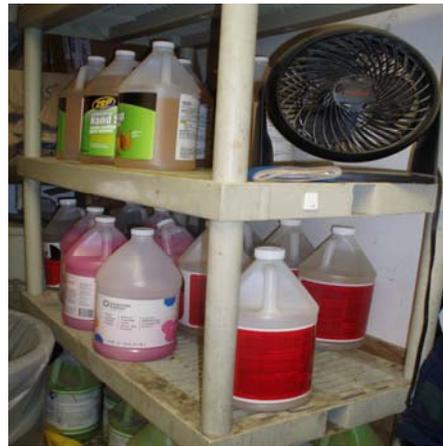
Photo 10 Cleaning supplies located in janitorial closet

Several plastic containers containing household and home improvement products (paint, janitorial supplies, landscaping chemicals) were observed throughout the Home Depot store during the site reconnaissance. These containers were not open as they were for sale and were not located near floor drains. Releases or stains were not observed during the site reconnaissance.

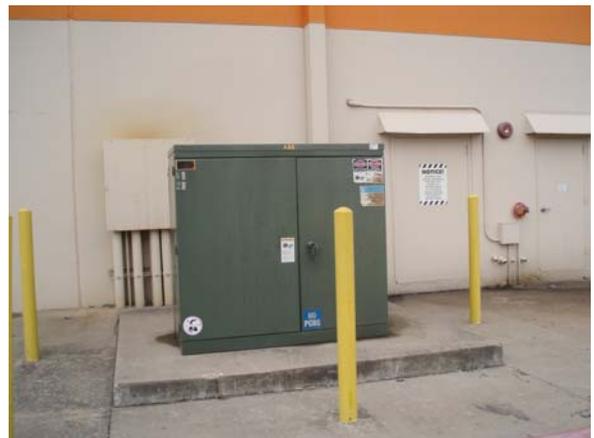
Photo 12 Pad-mounted transformer

During Terracon’s site visit, one “non-PCB” labeled pad-mounted transformer, owned and serviced by Austin Energy was observed on the eastern side of the Home Depot store. Transformers contain mineral oil which may contain minor amounts of PCB and could be considered “PCB contaminated” (PCB content of 50-500 ppm). Austin Energy maintains responsibility for the transformers, and if the transformers were “PCB contaminated,” the utility company is not required to replace the transformer fluids until a release is identified.

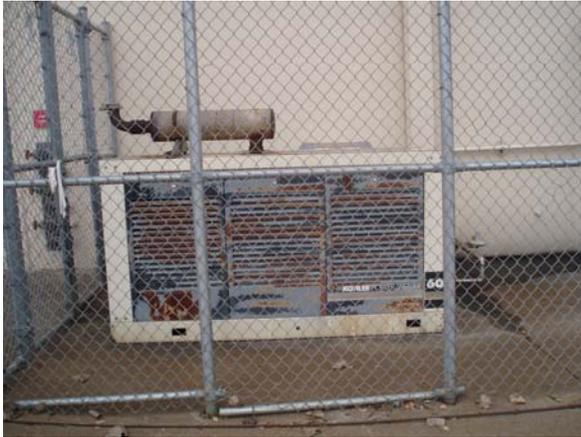
Photo 13 Emergency generator

One natural gas powered emergency generator was observed on a concrete pad north of the building during the site reconnaissance. No evidence of staining, noxious odors, or releases was observed in the vicinity of the on-site generator at the time of the reconnaissance. According to Dan (no surname provided) the Home Depot store manager, there have not been problems relating to the generator to his knowledge.

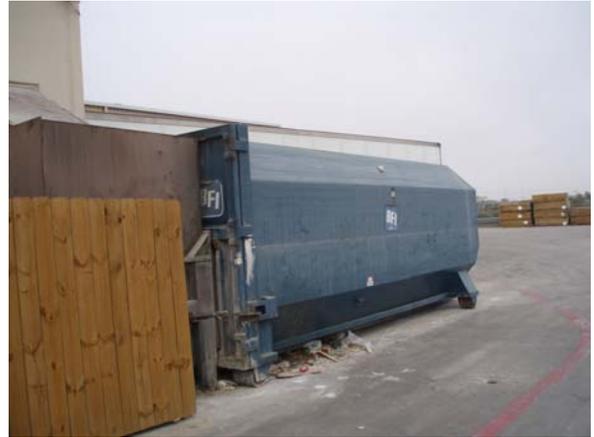
Photo 14 Trash compactor

A solid waste disposal compactor was observed at the northeast corner of the Home Depot store. The trash compactor is hydraulically operated. No surficial staining was observed on the asphalt surface beneath the hydraulic reservoirs or in the vicinity of the compactor at the time of the site reconnaissance.

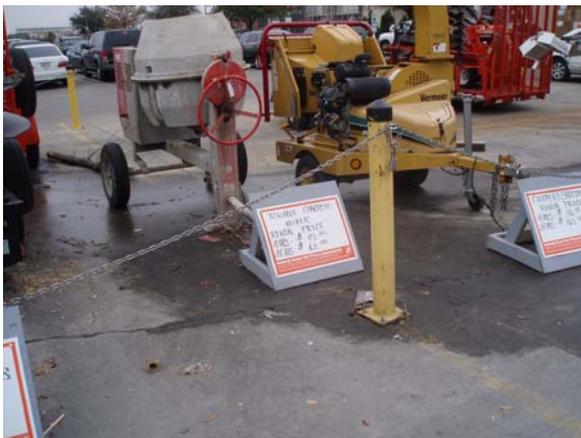
Photo 17 Rental equipment and staining on pavement

Staining was observed on the paved parking lot. The small stain was observed on the pavement beneath heavy equipment available for rent. The staining may have been a result of a past release from the rental equipment or from a car parked nearby. No other evidence of release was observed at the time of the site reconnaissance. The staining does not appear to present a REC to the site at this time.

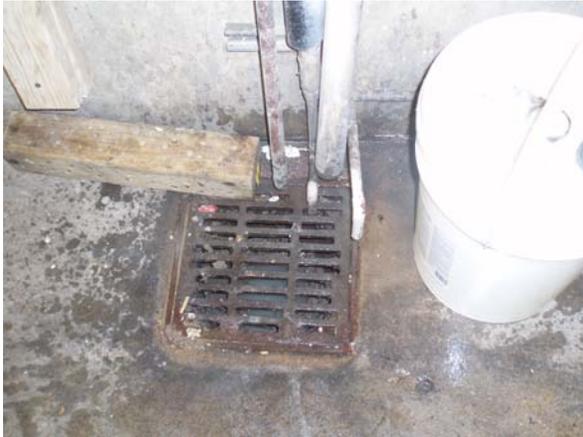
**Photo 19** Floor drain inside tool rental department (leads to oil/water separator)

According to Mr. Stephen Taft, the tool rental department manager, one oil/water separator is located in the tool rental department. The oil/water separator was installed during store construction in 1995. The oil/water separator collects run-off (dirt, oil, grease, etc.) associated with maintenance conducted on the rental tools. The condition of the separator is unknown. The oil/water separator is serviced via manhole cover openings outside the store on a regular basis by a contracted company. Based on the information provided by Mr. Taft, the oil/water separator does not appear to constitute a REC in connection with the site at this time. Please see the section on Laboratory hoods and/or Incinerators for more information on the maintenance performed on-site.

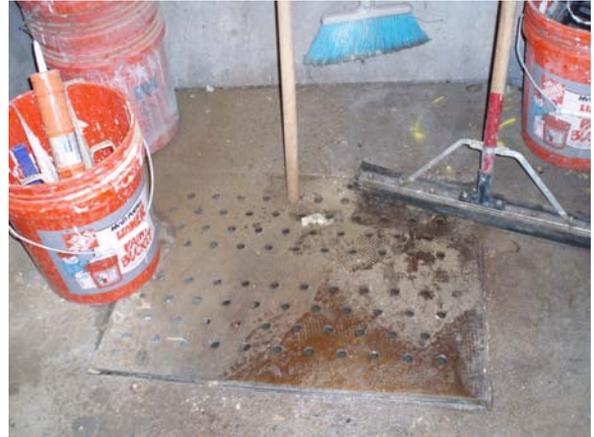
**Photo 20** Additional drains leading to oil/water separator

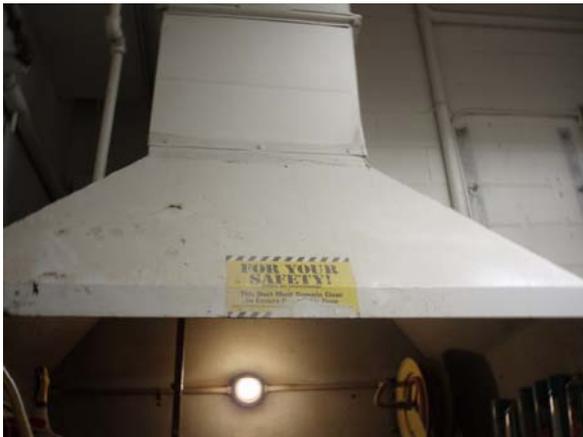
**Photo 21** Vent hood located inside tool rental department

A vent hood was observed in the tool rental department of the Home Depot store during the site reconnaissance. According to Mr. Stephen Taft, the tool rental department manager, the hood is associated with maintenance performed on-site on the rental tools. Maintenance activities on-site include oil changes, small engine repair, and part replacement. The hood is maintained by a contracted company on an as-needed basis.

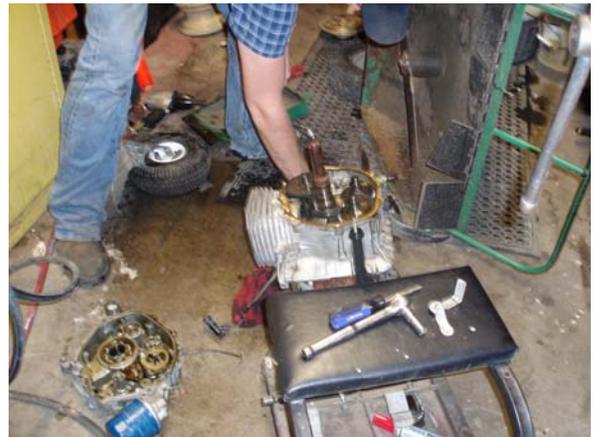
**Photo 22** Typical maintenance activities inside tool rental department
